CAN BUILDINGS BE MADE FIRE-PROOF?

By CORYDON T. PURDY, M. Am. Soc. C. E.

PRESENTED NOVEMBER 3D, 1897.

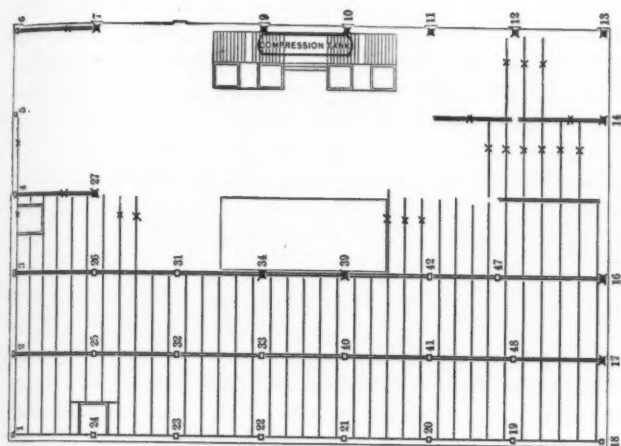
ROOF FRAMING
FIG. 7.

The location of the tank on the roof is shown in Fig. 7. It was 6 ft. in diameter and 25 ft. long, made of steel plates $\frac{1}{4}$ in. thick in the cylinder and $\frac{1}{2}$ in. thick in the heads, and had a capacity of about 5 000 galls. In working, however, only about half of this should be figured on, and the total weight of tank and contents when it fell was therefore probably not more than 30 000 lbs. It was supported by roof beams which were carried at one end by the girder between columns 36 and 37, and at the other end by the wall girder between columns 9 and 10, and enclosed with a tile wall and asphalt roof. The four beams under the tank were 15 ins. deep. The roof here, as elsewhere, was protected only by the suspended ceiling. None of the roof framing was fire-proofed, and no exception was made of the beams under the tank. The intensity of the heat at this point was also greater, for it was at the top of the flue. Whether the beams or the columns gave way because the factor of safety in them was not as great as it should have been, or the heat was simply too great for anything to withstand, and the absence of fire-proofing is alone to blame, matters little. The fact remains that good fire-proofing would undoubtedly have saved the tank, and if the tank had not fallen at all, the loss of the steel construction would have been, as estimated by the adjusters, not more than 5 per cent.

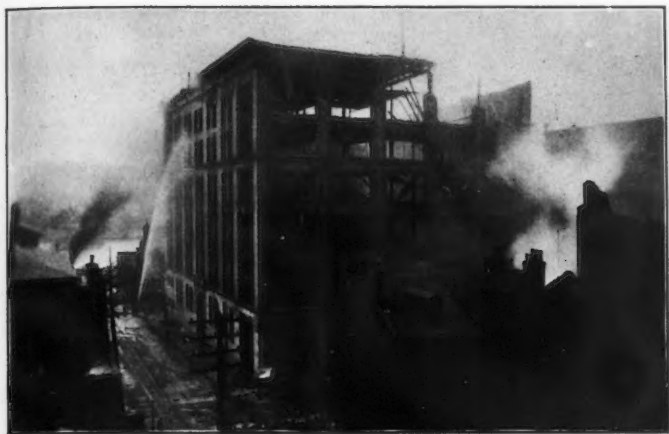
FIG. 1.

Plate III, Fig. 1, shows the condition of the Store Building after the fire, and Fig. 2 is a view on the first floor of the same building looking from the center of the building towards the fallen tank, which shows quite clearly in the background. This picture also shows the construction of the light court and the railing or balustrade which surrounded it. Plate IV, Fig. 1, is also taken on the first floor, but looking in the opposite direction. It shows the ceiling and some of the broken tile. The floor arches did not endure the fire as well on the upper floors as they did on this. Plate IV, Fig. 2, shows in the foreground how the terra cotta was flaked off and broken around the windows in the Store Building. In the background on the right it shows the ruin of the grocery store, the one-story building through which the street cars pass, and the side front of the Methodist Building. This picture was taken several weeks after the fire, and the repairs to the window frames and windows in the latter building had already been completed.

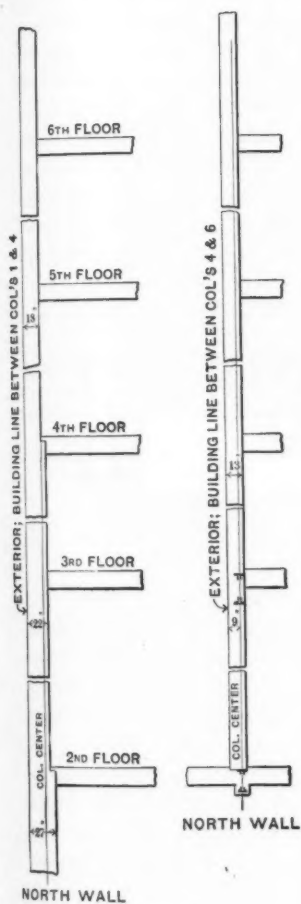
Fig. 9.

The east or party wall, shown with the west wall in Fig. 9, was also carried from floor to floor on the girders, but the front wall was self-supporting the entire height of the building, and the rear wall was nearly so. The horizontal parts of the front wall at the floor lines between the windows were carried on iron lintels resting on the piers, and not fastened to the steel frame. These lintels on most floors were close to the windows and exposed to the action of the fire. In the fourth story they were partially protected by a course of terra cotta, but the latter was fastened in place by iron anchor bolts which passed through the terra cotta so as to be themselves exposed. Fig. 10 shows two sections through the rear wall, a part of which was supported on iron at the second floor. This is shown by a dotted line in Fig. 1. The ceiling in the sixth story was suspended from the roof beams. It was composed of $1\frac{1}{2} \times 1\frac{1}{2}$ -in. T-bars, spaced about 12 ins. apart, carrying a solid tile about $1\frac{1}{2}$ ins. thick.

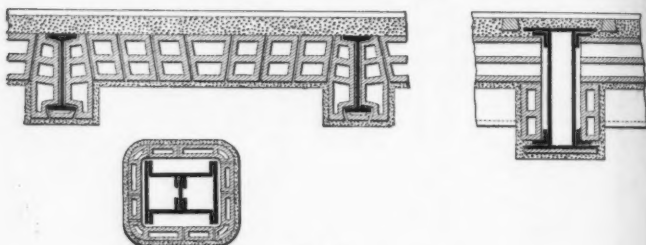
FIG. 11.

All the fire-proofing in the building was made of hard-burned material. The floor arches were 9 ins. deep, supported at each side by skewbacks especially designed to cover the entire side of the beam, and the joint between the arch proper and the skewback was made so that the top of the arch was flush with the top of the beam. The walls of all of this material were about $\frac{5}{8}$ in. thick, and the sections of the arches were of the old style side construction. The columns were covered with tile 2 ins. thick, having one hollow space and walls $\frac{1}{2}$ in. thick. All of this material was well erected. The floor sleepers, spaced about 14 ins. apart, were bedded in cinder concrete which covered the arches 4 ins. in depth, and the floor was finished with hard pine. This construction is shown in Fig. 11.

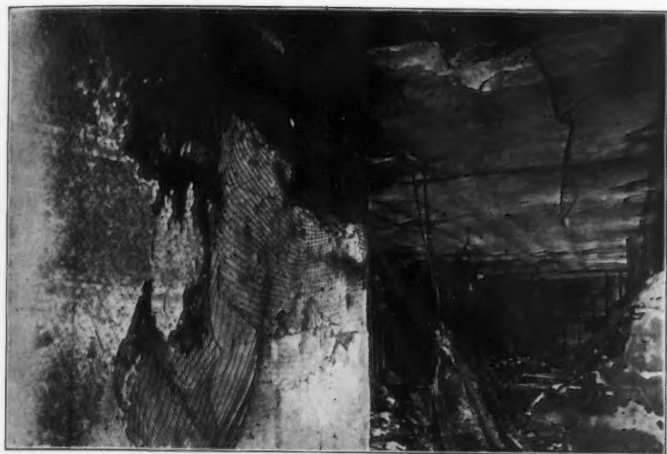
FIG. 1.

Plate VIII, Fig. 1, shows that the ornamental trimmings upon the electrolier, which were probably of thin spun brass, did not approach the point of fusion, and that small iron pipes were not softened enough to have become much bent. This photograph happens to present little detail, and gives much less information than could have been found by the sharp eyes of any good inspector in a ten-minute examination of the ruins; nevertheless, it causes the speaker to think it probable that the heat in this room was much less severe than in some of the fires in several small experimental buildings, constructed for testing the endurance of plaster on metal lath, which he has had occasion to witness at various times.
